RECORDS

STEAM BOILER EXPLOSIONS,

EDWARD BINDON MARTEN,

MIDLAND STEAM BOILER INSPECTION AND ASSURANCE CO.

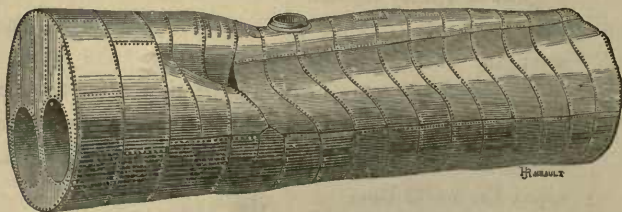
The theories as to the causes of explosion have been numerous. In the early days of the steam engine, when the steam was used only as a condensing medium and the pressure in the boiler was frequently allowed to get below atmospheric pressure, many boilers were destroyed by the excess of the external atmospheric pressure becoming too great, causing them to be collapsed or crumpled up ; and this led to the use of the atmospheric valve still found on old boilers. Even so lately as last year, 1865, a boiler in the neighbourhood of Bury, Lancashire, has suffered in this way by collapse from external pressure ; its appearance after the accident is shown in Fig. 1.

which is copied from a photograph. The early explosions were so palpably due to the weakness of the boilers, which compared with those of the present day were most ill constructed, that no one

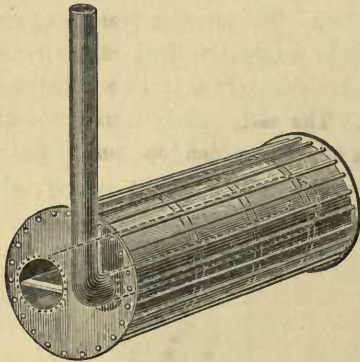
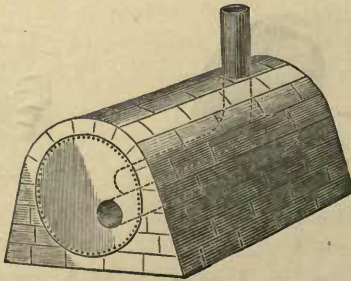
*Fig. 6.*

at that time used only at or below atmospheric pressure as a means of obtaining a vacuum by condensation for working by the external pressure of the atmosphere, so little was pressure of the steam thought of, that boilers were proposed and it is believed were actually constructed with hooped wooden shells, like barrels, and internal fireplaces and flues of copper; and even a stone chamber was named as being a suitable shell for a boiler, with internal fireplace and copper flue passing three times the length of the inside and out at the top, like an ordinary stove and piping. These boilers must have been something like the sketches given in Figs. 6 and 7,

and were intended to be exposed only to the external pressure of the atmosphere.

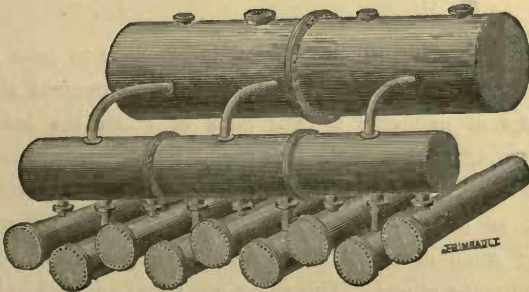
Fig. 10.

and boilers of this construction are still to be found in use at some of the older works at the present day. As the outside shell and front plate are $1\frac{1}{2}$ inch thick and are not exposed to any wear at all, these boilers are sufficiently strong. A duplicate front plate with set of tubes attached is always kept on hand in case of need. Another form of cast-iron boiler is shown in Fig. 9., made in several parts put together with flange joints, with an internal fireplace and flue also made of cast iron. When cast iron was used for the parts exposed to the fire in boilers intended for high pressure, it was sometimes employed in the form of tubes of small diameter and proportionately thinner; as in Woolf's boiler, so much spoken of in the evidence before the parliamentary committee of 1817. This boiler, shown in Fig. 10., consisted of nine cast-

iron pipes, about 1 foot diameter and 9 feet long, set in brickwork

so that the flame played all round them. These small tubes were connected with another of larger size placed transversely above them, forming a steam receiver, and this again with a still larger one, which formed a steam chamber. No details of any explosions of the three last mentioned boilers have been obtained; but it is known that the cast iron was found a most treacherous material, especially when exposed to the action of the fire; and that the effect of explosion was very disastrous, because the boiler burst at once into many pieces, each of which was driven out with great velocity, and the danger was not mitigated by the circumstance of large masses holding together, as is found to be the case with wrought-iron boilers when exploded.

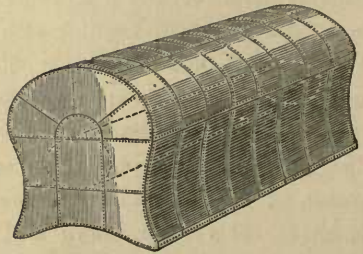
Fig. 12.

and plain flat sides, which could only be made to bear even the smallest pressure by being strengthened with numerous stays. In most cases of explosion of this class of boiler the bottom was torn off, owing to the angle iron round it being weakened by the alternate bending backwards and forwards under each variation of pressure, as all the sides and the bottom must be constantly springing when at work. Such was the explosion at Chester in 1822, and many others. This shape was soon improved in its steam generating powers by making the sides concave instead of flat, as shown in Fig. 12, so that the heating surface was greater and also

Plain cylindrical and wagon boilers have for many years been made with internal tubes of various shapes and arrangement, through which the flame passes to add to the heating surface. These are shown in dotted lines on the previous drawings of wagon boilers, Figs. 11 and 12. They are also shown in Fig. 32, where a tube

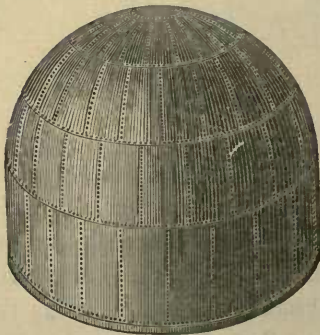
Fig. 17.

angle constructed either of bent plates or angle iron, as in Figs. 17

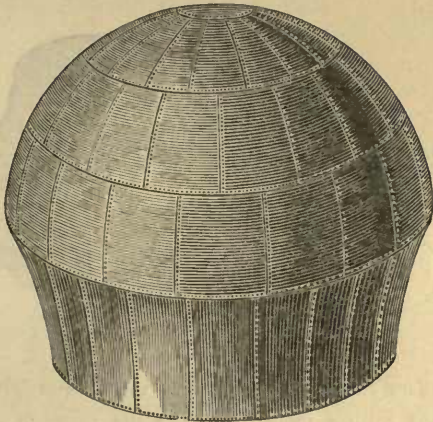
Fig. 18.

and 18, which represent the forms known so well in the

Staffordshire district as the common Balloon or Haystack boiler. Many of these have been made of very great size, measuring as much as 20 feet diameter, and containing so much water and steam as to be most formidable magazines for explosion. Perhaps no form of boiler has exploded more than this, partly because of the great number that have been used, but chiefly because of the inherent weakness of the shape. The records however have not been obtained of the great majority of these explosions, because they seldom caused sufficient damage or loss of life to attract much attention, as these boilers generally worked in isolated positions at collieries. The bottom is only prevented from blowing down into the fireplace by numerous stays from the top, and the angle iron round the bottom of the sides is much tried by the constant springing of the plates under every alternation of pressure; and the weakness thus occasioned is increased by the angle resting on the brickwork and being exposed to corrosion. The effect of this continued alternation of strain is well shown by the elastic model exhibited.

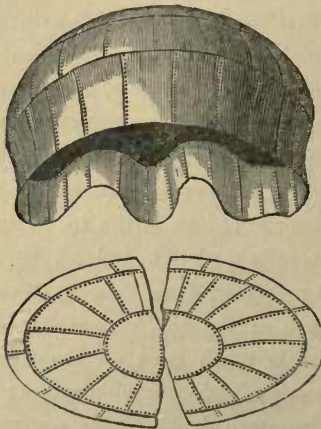
Fig. 20.

explosion was only slight, the effect of the bottom giving way, and the consequent rolling over caused by the reaction of the issuing steam and water, is clearly seen. Another example that occurred at Wednesbury in 1862 is shown in Fig. 20, where the explosion was

rather more violent, the bottom of the boiler being torn off all round and left upon the firegrate, and rent nearly into two pieces; while the top and sides were thrown some height in one mass, and were only put out of shape by the fall. The weakness of this boiler had been further increased by making the bottom angle of angle iron, as

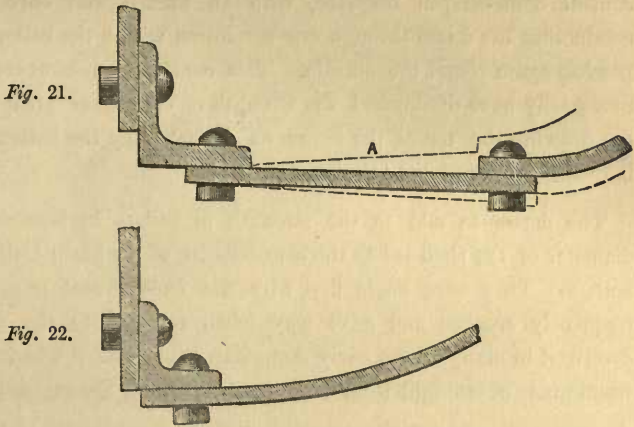
shown enlarged in Fig. 21, with a ring of flat plate A interposed

between the angle-iron ring and the concave bottom of the boiler ; so that all the effect of the springing of the bottom, as shown by the dotted lines, was thrown upon the angle iron, which was accordingly found cut off all round. Had the concave bottom been made to rise direct from the angle iron, as in Fig. 22, the springing could not have been so great, and the angle iron would only have had to stand the shearing strain of retaining in its place the rigid bottom ; but as about one foot all round the bottom was flat, and the concavity was only in the central part, the angle-iron ring had to bear an up and down strain, as shown by the dotted lines in Fig. 21, and the bending action was more severe than it would have been if the bottom had even been made quite flat all over.

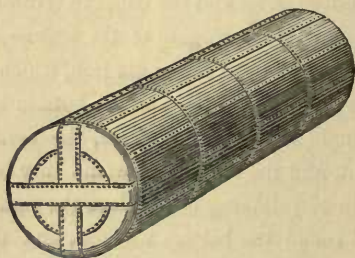
Fig. 24.

The desire to add to the strength of boilers by lessening the diameter of the shell led to the construction of the Plain Cylindrical boilers. They were made first with flat ends of cast iron, which frequently cracked and gave way when exposed to the fire, as described in many of the early American explosions. The flat ends when made of wrought iron, as shown in Fig. 24, are exposed to the

same strain as the bottom of the balloon and wagon boilers, and are constantly springing with variation of pressure like drum heads, causing injury to the angle-iron joint. They also require long stays through them to hold in the ends, and these are subject to so much vibration that they seldom continue sound for long together, especially when joined with forked ends and cotters.

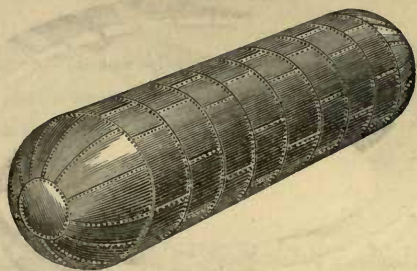
Fig. 25.

Fig. 25 ; and plain cylindrical boilers with these hemispherical ends

are now so commonly used that they far outnumber any other form of boiler. Their shape renders them very strong, as the whole of the iron is in simple tension, and internal pressure has no tendency to alter the shape, as is shown by the elastic model exhibited. There is one circumstance very much in favour of the plain cylindrical boilers, and that is that they can be so easily cleaned and repaired, as a man can stand properly at his work at every part and the whole of the interior surface is exposed equally to view. They are of course exposed to all the evils of boilers externally fired, the part under greatest strain being weakened by the action of the fire; and the bottom is also exposed to injury from accumulation of mud and chips of scurf, which cannot be prevented from falling there, and lying upon the part exposed to the direct action of the fire. When made of great length, such as 70 or 80 feet, as is the practice for applying the waste gas from blast furnaces, these boilers are also liable to seam-rips or "broken backs," owing to the greater expansion of the bottom exposed to the fierce flame for its whole length, than of the top which is kept cooler by exposure to the air; and it would therefore be better to have a succession of short boilers, rather than only a single one, where great length is required.

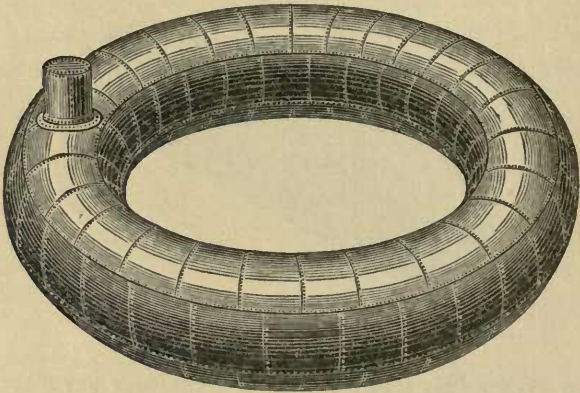
Fig. 26.

forming a Ring or Annular boiler. This boiler is shown in Fig. 26,

and is 5 feet diameter with 25 feet external diameter of the ring, or a mean length of about 63 feet ; it has been found to work well for some years, although exposed to the heat of six puddling furnaces.

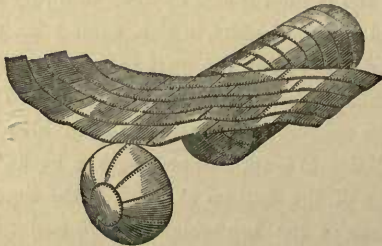
Fig. 27.

Explosions of plain cylindrical boilers have been very frequent indeed, although they have not caused a proportionate number of deaths, because they work usually in isolated positions at colliery and mine engines. The sketch shown in Fig. 27, represents an

explosion that occurred at Darlaston in 1863, and illustrates the way in which these boilers usually explode. They generally open first at a longitudinal seam over the fire, which has become deteriorated by accumulations of scurf preventing proper contact of the

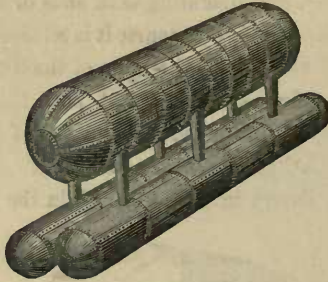
Fig. 29.

In order to avoid having a large diameter for plain cylindrical boilers, especially where exposed to the fire, boilers have been used that have supplied the required steam power by a combination of several cylinders of small diameter. One of these known as the Elephant boiler, has been so much used in France that it is sometimes called the French boiler; it is shown in Fig. 29,

and consists of two cylinders of small diameter connected by upright conical tubes to a large cylinder above. Another form called the Retort Boiler, shown in Fig. 30, has been described at a previous

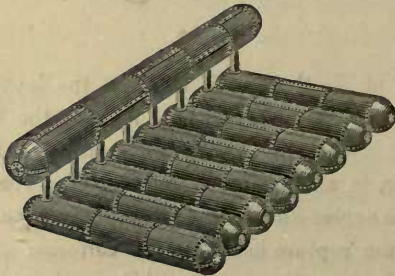
Fig. 30.

meeting of this Institution (see Proceedings Inst. M. E. 1855 page 191). The disadvantages of these two combinations of plain cylinders are that they are not easy to clean or examine internally, and also there is not free exit for the steam, which has to find its way along small channels, and carries the water away with it, causing priming, and also retarding the generation of steam and

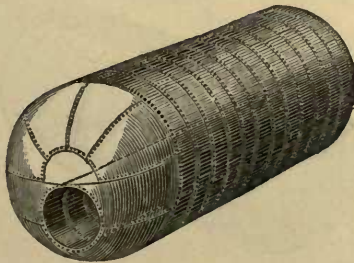
Fig. 32.

passes from over the fire to the front of a plain cylindrical

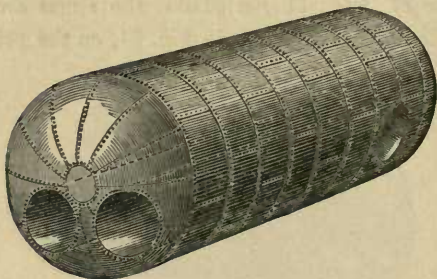
Fig. 33.

boiler; in Fig. 33 two tubes pass from the sides to the front: in

Fig. 33, No. 47, 1869, where two tubes were taken out, and Fig. 34, No. 42, 1867, where one tube was taken out. One of the most frequent and serious causes of loss of strength is the repairing of externally fired boilers. Not only are the patches sometimes

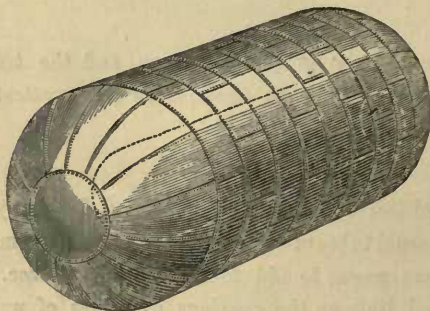
Fig. 34.

Fig. 34 the tube passes from the back, but returns over the fire and

passes again to the back: and in Fig. 35 a tube from the back

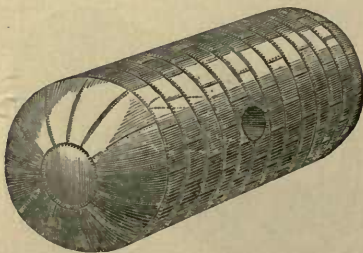
Fig. 35.

passes out through a cross tube in each side. The boilers in all these cases are fired externally. This addition of tubes has tended very much to increase the size of these boilers in order to make

only bolted on in a temporary manner, as in Fig. 35, No. 29, 1869, but even where they are rivetted on there is an entire want of bond or crossed joint, as in the case of the exploded boilers shown in

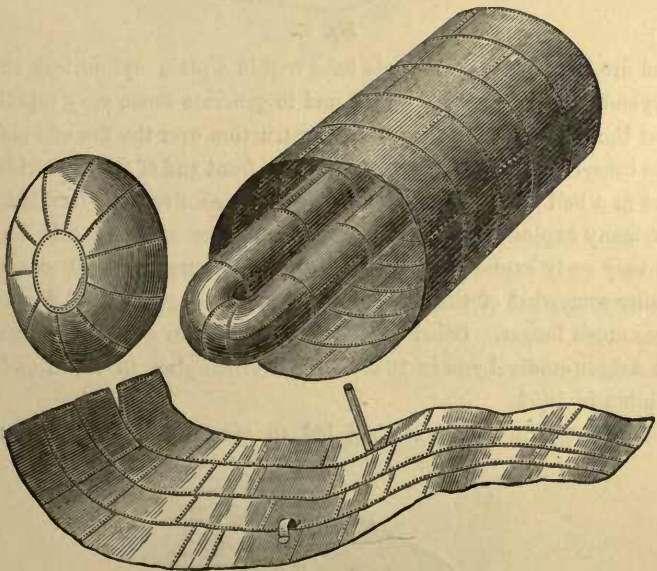
Fig. 36.

Explosions of these boilers have sometimes taken place by collapse of the tubes, but much more generally by the failure of the shell over the fire, as shown in the sketch Fig. 36,

representing an explosion that occurred at Wolverhampton in 1865, in which the first rent took place in a seam over the fire where frequent repair had led to a considerable length of longitudinal seam being in one continuous line. The four plates over the fire parted and opened out until they had ripped two seams completely

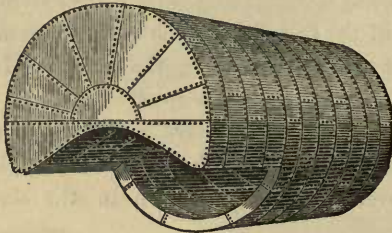
Fig. 37.

A modification or amalgamation of several of the forms of boilers already mentioned led to the construction known as the Butterley boiler, shown in Fig. 37, with a wagon-shaped end over

the fire, continued in a single tube within a plain cylindrical shell beyond. This boiler has been found to generate steam very rapidly; but the extreme weakness of the construction over the fire and along the tube, especially at the part where the front end of the tube widens out in a bell mouth to meet the wagon-topped fireplace, has led to so many explosions that few boilers are now made of this form. A very early explosion that occurred at Edinburgh in 1821 was of a boiler somewhat of this shape, only that the wagon-topped fireplace was much longer. Other explosions of this form of boiler occurred at Ashton-under-Lyne in 1845, at Wolverhampton in 1854, and at Tipton in 1856.

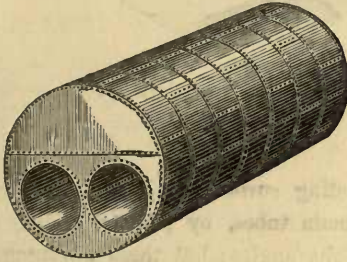
Fig. 39.

and the great number of boilers of this form used in Cornwall gave it the name of the Cornish boiler. The exceedingly good duty performed by these boilers led many to believe them the most perfect for economy and durability; but the great number of explosions, or more properly of collapsed flues, that have happened, have altered this opinion, and led to the double-flue boiler shown in Fig. 39, in which not only is the heating surface increased but the

strength also, by having two tubes of smaller diameter in the same shell. There are a great many varieties of the two-tube boiler, which have been made for the purpose of obtaining various particular results. In some cases the two tubes have been made to unite into a single tube immediately behind the fires, forming what is known as the Breeches-tube boiler, as shown in Fig. 40, and in other

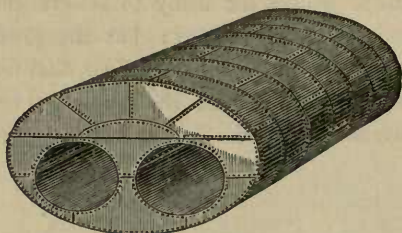
Fig. 41.

shown in Fig. 41, with the two tubes continued through from end

to end. The heating surface has also been increased, and the strength of the main tubes, by placing smaller transverse tubes across them at right angles; but these advantages are gained by increased complication, leading of course to greater difficulty in examination and repair.

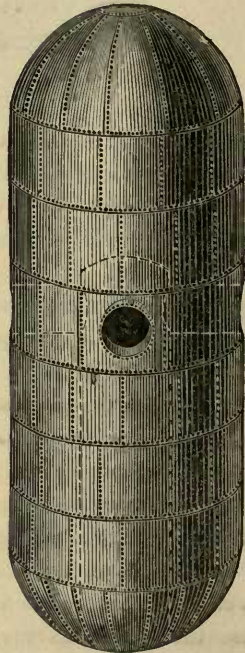
made for two furnaces ; and about 7 feet diameter and 16 feet high. The size has since been increased to 10 feet diameter and 28 feet high, as shown in Fig. 44. These boilers are made for one, two, three, or four puddling furnaces ; and consist of a cylinder with spherical ends, standing upright, with a central tube from the bottom to about half the height, into which the side tubes join. The heat from each furnace plays over a portion of the shell, and then passes through the side tubes and down the centre tube into the underground flue to the chimney.

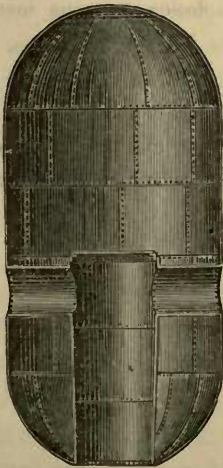
Fig. 45.

Some of the most fatal explosions of these boilers have arisen from careless construction. Such was the case in an explosion at Dudley in 1862, shown in Fig. 45, where the crown plate forming

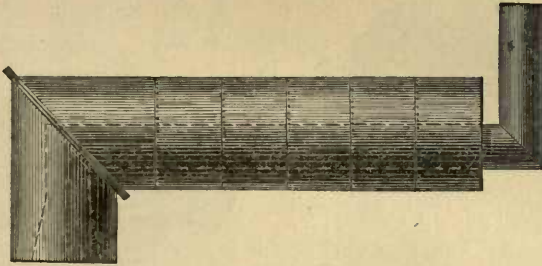
Fig. 48.

A further arrangement for a single-furnace boiler is the Elbow boiler, shown in Fig. 48, where the two difficulties mentioned in the previous boiler are avoided.

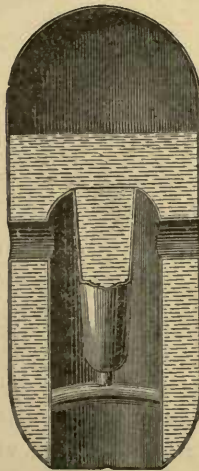
Fig. 49.

been at work many years is shown in Fig. 49, with an internal fireplace and a suspended cone and cross tube for increasing the

heating surface. This boiler is set in brickwork in such a way that the heat passes through the side tubes and round the exterior shell before going off to the chimney.

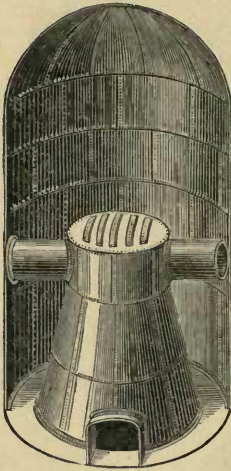
Fig. 50.

A very fatal explosion at Stoke-upon-Trent, in 1863, resulted from an attempt to work a boiler of somewhat the same general form, but without the same careful attention to the details of construction.

This boiler is shown in Fig. 50 ; the internal fireplace is of conical

shape, 4 ft. 6 ins. diameter on the top and 6 ft. 10 ins. at bottom, and was joined to the external shell by a flat annular bottom. Almost the first time it was worked at high pressure the conical fireplace collapsed, breaking off at the seam at the top of the cone, and blowing down upon the grate, as shown in Fig. 51. The flat bottom was then left without the support of the cone and side tubes, and gave way all round the outside angle iron; and the top flew up a great height into the air, and fell a crumpled heap, as shown in the sketch. In this case the only wonder is that a boiler of such weak construction worked at all without explosion.

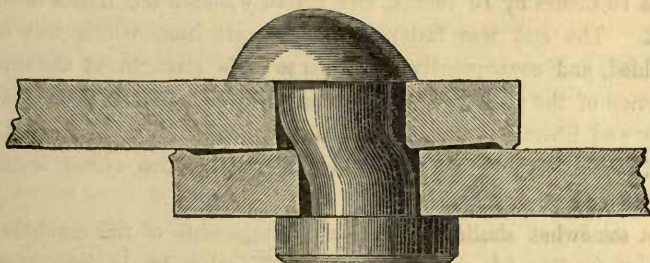
made, the errors have to be partially rectified by using the drift in the holes to an unwarrantable extent, and then using imperfect rivets to fill up the holes that do not correspond with each other; and the mischief is too frequently increased afterwards by excessive caulking, in the endeavour to stop the leaking which is sure to show itself. In this way a boiler is often exposed to most unequal internal strain between its several parts before it is set to work at all; and when the heat is applied to it, the mere expansion causes undue contortion, and leads to seam rips, and ultimately to disaster. Several specimens of faulty rivetting and caulking were exhibited to the meeting, and a sketch of one of them is shown in Fig. 52.

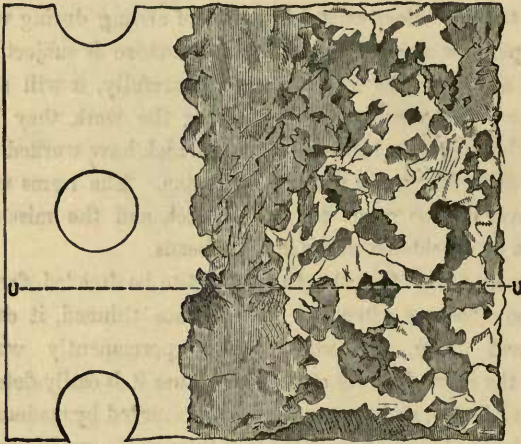
Fig. 56.

This explosion occurred at Aberaman in 1864. The corrosion

had been seen going on for years, and was not considered sufficient to cause danger; but the depth to which it extended through the thickness of the metal is seen in the half size section, Fig. 57. Another sample equally curious was exhibited to the meeting, and shown in Figs. 58 and 59, taken from the sweep plate over the fire in a plain cylindrical boiler which had worked about ten years. The feed water was occasionally bad, and attacked the iron over the area DDD, where unprotected by scale. The protection afforded by scale against occasional corrosive feed water is worthy of notice. In the two specimens exhibited it is seen that the protection has been perfect where the scale has not been chipped off; and the edge of the sound part projects over the hollow, as

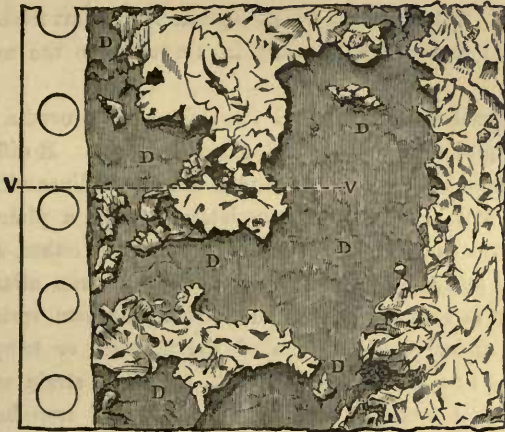
Fig. 58.

seen in the half size sections, Figs. 57 and 59, the corrosive water

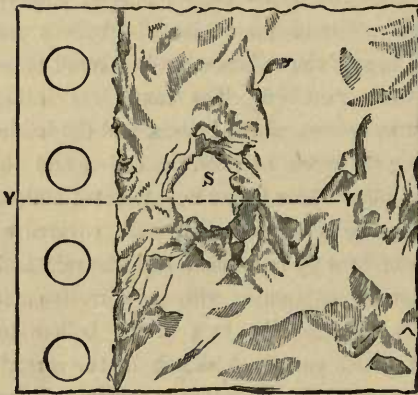
Fig. 62.

as shown in the sketches Figs. 62 and 63, which represent an instance of corrosion after eight years' working; although nothing

forms a better covering than sand for preventing loss of heat by radiation. In both these examples it will be seen that the corrosion has continued until the thickness of the plate has been so eaten away that a hole has been burst out at SS. A very good covering is formed by brickwork in cement; or various cements made for the purpose, which adhere to the surface of the plate and yet show leakage; or such materials as sacking or felt; or sheet-iron casing, leaving about 6 inches of air space all round the boiler.

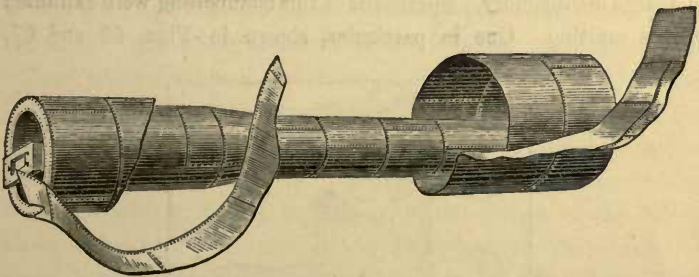
Explosions have also taken place from general corrosion of the surface of the boilers in the flues. A new boiler which was set on sidewalls built upon a foundation of porous rock was found to have become corroded all along the bottom in less than two years, owing to the dampness which rose from the foundations causing a constant presence of vapour. The corrosion was peculiar, and more like that found on old iron left for a long time in a damp place; for the iron plate fell to pieces when touched, and large flakes could be raised from the surface, and the greater part of the thickness of the plate could be removed with the fingers. Somewhat similar corrosion had taken place in a boiler which exploded at Loughborough in 1863; the bottom of the shell became rent at the corroded part, and as the fracture continued spirally round the boiler several times, nearly all the shell was peeled off in the curious manner shown in Fig. 64. The explosion shown in Fig. 65, which occurred at Leeds in

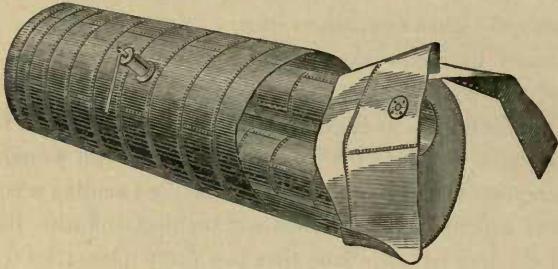
Fig. 65.

1866, also arose from corrosion of the bottom of the boiler.

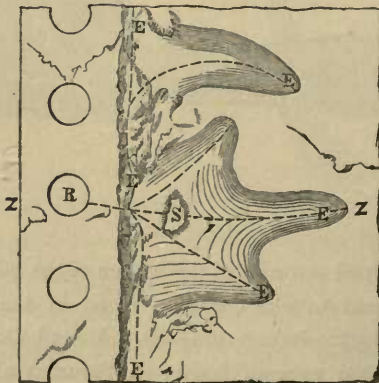
Fig. 66.

and the rivets loosened by the extra expansion so caused. This is sometimes done intentionally, in order to loosen the scale by the greater expansion of the iron than of the scurf. When the boiler is again set to work, the seams and rivets leak and cause that corrosion which is called channelling. This has been observed to occur to such an extent that all the seams in a boiler have been seen thus corroded; and the same has sometimes been found in all the boilers in a large manufactory. Specimens of this channelling were exhibited to the meeting. One in particular, shown in Figs. 66 and 67,

water from the leaking rivet R, in cutting a series of channels into the plate along the course of the dotted lines EEE, and producing a hole in the plate at S. This corrosion had been going on for about four years, but was in a part of the boiler seldom seen in ordinary examination. Many explosions have resulted from this form of corrosion; for when a rent is once made, the fracture continues along the thinned channel of the plate.

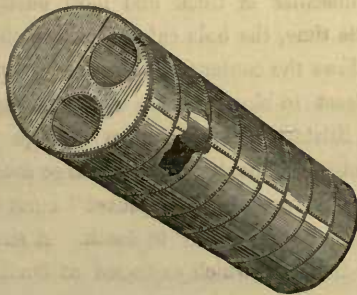
was blown out on one side of the boiler, allowing the steam and water to escape without displacing the boiler; the thickness of the plate at that part had been reduced to 1-8th inch by corrosion in about 1½ years, which had been caused by leakage at the seams from inefficient repair with bolts instead of rivets, and also from the moisture having been allowed to be kept against the plate by the brickwork. But even under such circumstances, if the piece blown out should be from the bottom, the whole boiler may be thrown a great distance by the reaction of the issuing steam, as in an explosion at Leeds in 1865, shown in Fig. 70. If the corrosion

extends for any length, the first rent is almost sure to continue until a complete explosion is the result. Several of the small models exhibited to the meeting showed the line of fracture in various cases of explosion. One showed the appearance of a plain cylindrical boiler after explosion caused by corrosion along the whole length where it rested on brickwork; this explosion occurred at Wigan in 1865, and a sketch of it is given in Fig. 71.

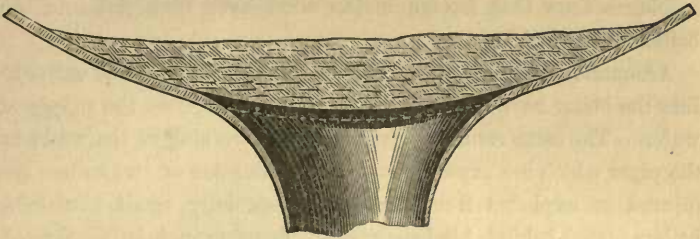
Many explosions of boilers have been caused by accumulation of scurf. The mischief is not so much from scurf being gradually deposited all over the interior of the boiler to a dangerous thickness as from the chips off the sides falling in heaps on the bottom. The plate beneath this accumulation becomes overheated, because not in contact with the water, and softens and sinks down into a "pocket," which if unnoticed will soon burn quite through. If the scurf that has caused the mischief is thick and hard enough to resist the pressure for a little time, the hole enlarges, until the scurf suddenly gives way and allows the contents to issue so violently as to disturb the boiler, or at least to blow the fire out of the grate. Such was an explosion at Bilston in 1863, where a large plain cylindrical boiler, 9 ft. diameter, was heated by three large fires placed side by side along the bottom; and a large "pocket" burst out over the third grate, and scalded the attendant to death. A similar pocket in a boiler, 4ft. 6 ins. diameter, which exploded at Dudley in 1864, after having been at work six weeks without cleaning, is shown in the

transverse section, Fig. 72. In this case the scurf had filled

up the circle of the boiler to a depth of 3 inches at the bottom, as shown in the drawing, and was of a very hard description; and the boiler plate was bent out in a gradual curve, and thinned to about $\frac{1}{16}$ inch, the original thickness being $\frac{1}{2}$ inch.

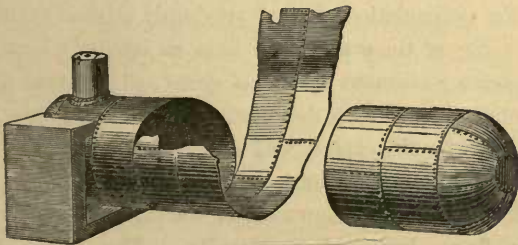
revealed some far more probable reason. For instance, shortness of water was stated as the cause of the explosion, at Abercarn in 1865, of a single-tube boiler with a very large flue tube, which collapsed upwards from the bottom. The top of the tube and the sides of the shell had not the slightest mark of overheating, although exposed to the flame of three furnaces, one of which worked through the tube, and the others on each side of the shell. In this case the cause of explosion was clearly the weakness of the tube, and not shortness of water. It is erroneous to suppose that if a boiler runs dry, or if the feed is turned into a red-hot boiler, there must necessarily be an explosion. If a boiler unconnected with any other runs rapidly empty, from the breaking of the blow-off pipe or any such cause, it will simply get red-hot and sink out of shape upon the fire, as may often be seen, but no explosion would happen. If the water only falls gradually, as it would if the feed were turned off and evaporation continued, the parts exposed to the fire would get overheated as the water left them. If the subsidence of the water were very slow, those parts might get red-hot, and so much softened and weakened as to be incapable of bearing the pressure, when an explosion would take place, as at Smethwick, in the present year, where the flues were set above the water line, as shown in Fig. 74.

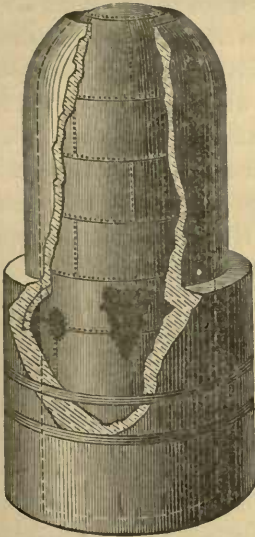
at Kidderminster, the tube of which collapsed in 1865, as shown in Fig. 76. It was heated by four furnaces, one of which

worked into the tube, one under the bottom, and one on each side ; and all the furnaces worked into the same end of the boiler. The tube was found to have partially collapsed at that end, and the top had dropped 11 inches. This was repaired in the first instance, but was afterwards again found injured by overheating, although not so seriously. It is very probable that the extremely rapid ebullition from the sides and bottom, from which the steam had to pass up the narrow space between the tube and the shell, produced such a foaming that very little solid water could reach the top of the tube where it was exposed to extreme heat.

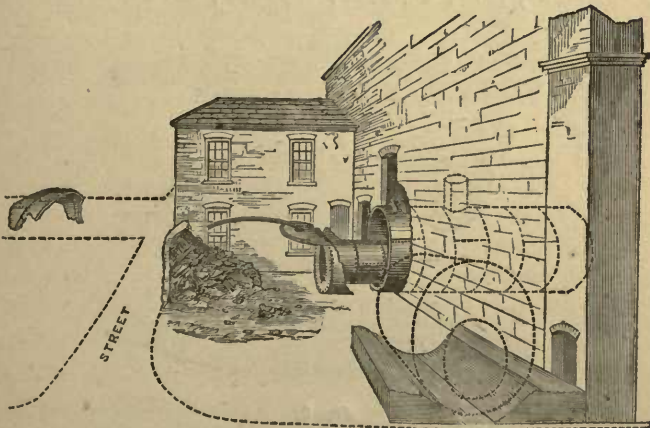
Fig. 1.

Although the importance of periodical examination as the best safeguard against explosion is generally admitted, a great number of those who make or use boilers have not at present sufficient belief in its importance to adopt this course. Boilers are still constructed or set in such a manner as to render examination next to impossible ; and are continued to be worked without making it the duty of those who mind them, or of any one else, to examine every part at frequent intervals ; and hence such explosions have occurred as shown in Fig. 1, No. 12, 1870, in which the original position of the

boiler before explosion is indicated by the dotted lines. . It is thought

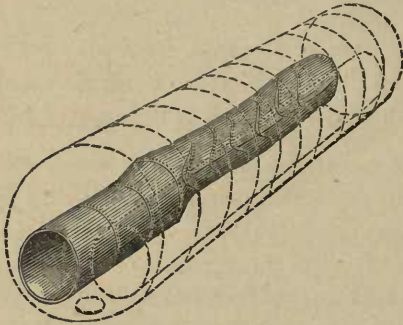
Fig. 2.

furrowing on the inside or channelling on the outside, such as caused the explosions of the originally good boilers shown in Figs. 2, 3, 4, and 5, Nos. 35, 1870; 50, 1866; 46, 1869; and 25, 1870.

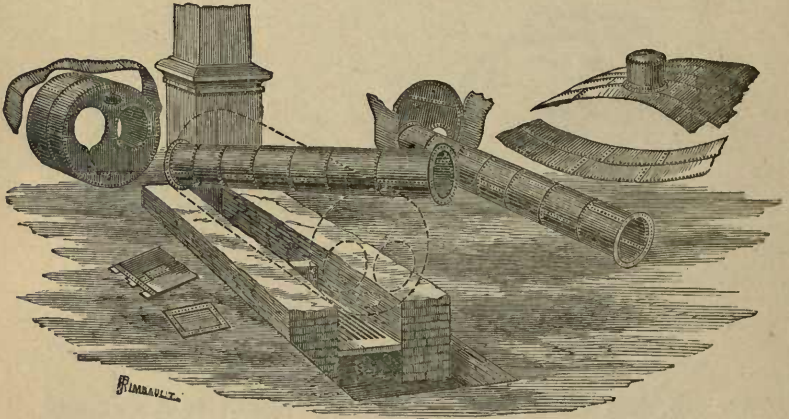
Fig. 6.

The opinion is more general than many are aware of, that explosions as a rule are caused by shortness of water and the sudden turning on of the feed water upon red-hot plates; and the appearances of injury in the plates from fire, arising in the ordinary

course of working, have been frequently mistaken for signs of overheating from shortness of water at the time of explosion, as illustrated in Figs. 6 and 7, No. 24, 1867, and No. 59, 1866.

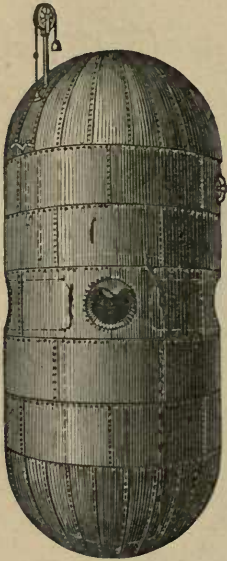
Figs. 11.

cannot be scattered suddenly near the overheated parts, but must rise gradually up the sides; and the boiler would have gone to pieces from the giving way of the softened parts long before the water reached them, as was the case in the explosions shown in Figs. 11 and 12, end of 1868. The experiment of injecting cold water into red-hot boilers has been carefully tried more than once, without producing any explosion.

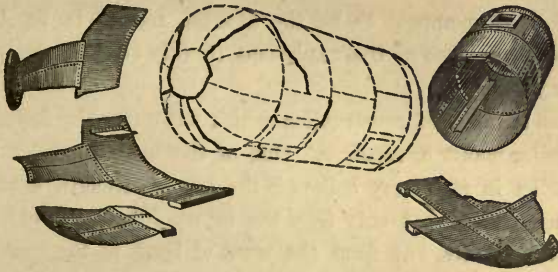
Fig. 13.

Before considering in detail the causes of explosion, it is necessary to recall to mind that beyond question there is sufficient accumulated force in any working boiler to cause all the violent effects of an explosion, if this force be suddenly liberated. In Figs. 13 and 14, No. 18, 1869, and No. 63, 1866, are shown the violent effects of the

rupture of vessels employed for steaming rags, which were filled with steam only. In ordinary boilers however there is present,

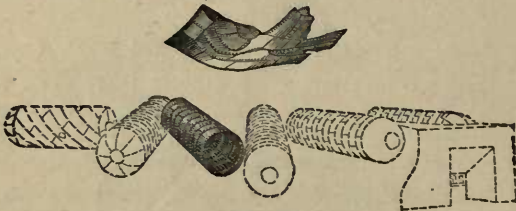
Fig. 15.

First as to faults of construction which fall under the department of the boiler maker or repairer. One of the most apparent causes of explosion in stationery boilers is the loss of strength occasioned by frequent repair, not only from the injury done to the old plates by removing rivets, but from the want of bond in the new work.

This has led to many of the explosions of the Plain Cylindrical boilers, such as are shown in Figs. 15, 16, and 17, No. 45, 1869, No. 32, 1870, and No. 20, 1870. Where the plates are arranged

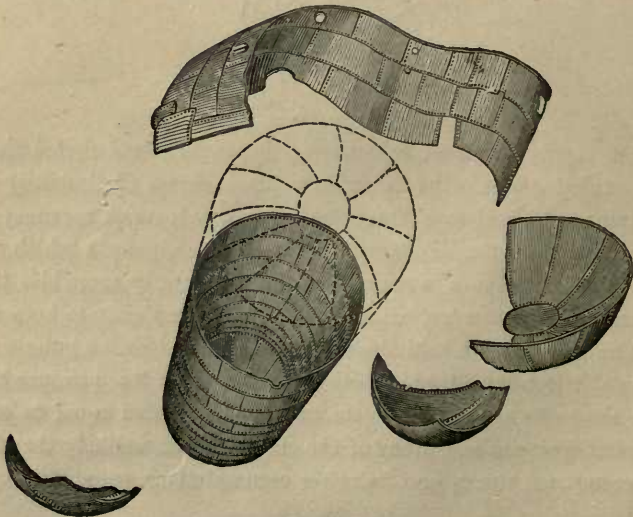
Fig. 16.

longitudinally instead of in rings, the danger is increased, as there is less chance of a dangerous rip being arrested by a crossed joint.

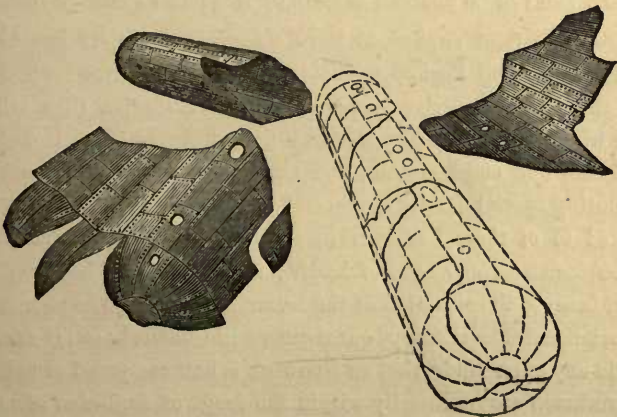
Fig. 18.

So great a number of boilers with continuous longitudinal seams, especially in the North, have worked for twenty or thirty years, that it can hardly be supposed they are any weaker than the boilers made in rings; but they are more liable to explode, for if a seam rip occurs, it more easily extends along the seam, and leads to the general break up of the boiler, shown in Fig. 18, No. 59, 1869.

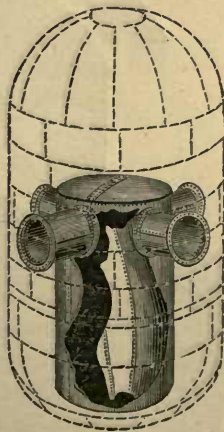
Fig. 21.

Those shown in Figs. 21 and 22, No. 23, 1870, and No. 53, 1869, were from the collapse of

the central tubes, which were weakened by external and internal corrosion respectively. In Fig. 24, No. 35, 1868, the shell was in bad

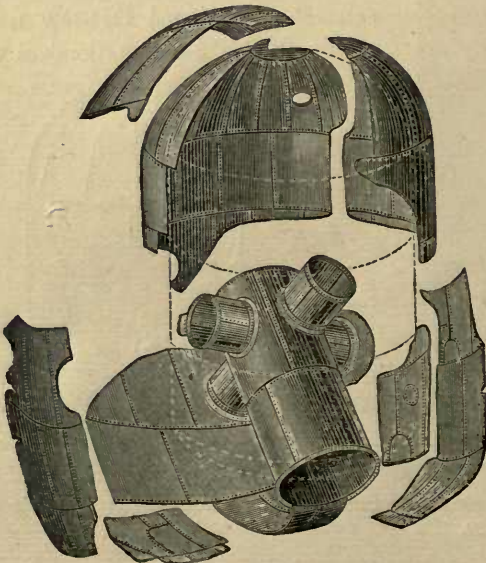
Fig. 24.

cases of explosion there was no pressure gauge on the boiler, or the gauge was out of repair in consequence of being placed on the steam pipe, so that it vibrated with every stroke of the engine; as in the examples shown in Figs. 24 and 16, No. 35, 1868, No. 32, 1870, pages 70 and 74.

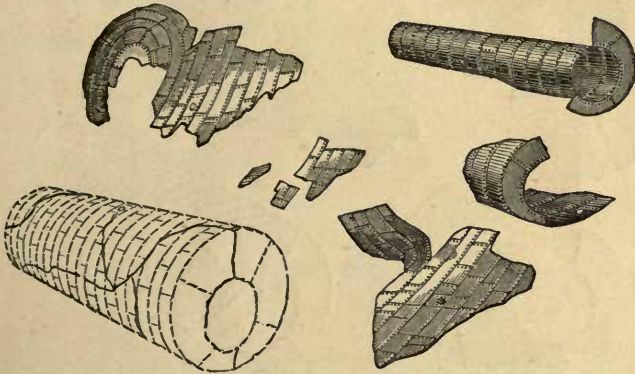
Fig. 23.

The greatest number of explosions and the greatest loss of life and personal injury have been in the case of Cornish and Lancashire boilers, or others with internal flues. In the county of Cornwall itself there have been many explosions, as often from the rupture of the shell, Fig. 23, No. 58, 1869, as from the collapse of the tube,

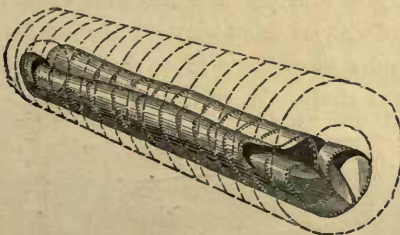
Fig. 25.

Fig. 25, No. 35, 1869. The temporary patching on some of these old boilers was most extensive, Fig. 26, No. 52, 1869, and the only wonder really was that they held together as long as they did. The belief that shortness of water is the only cause which can

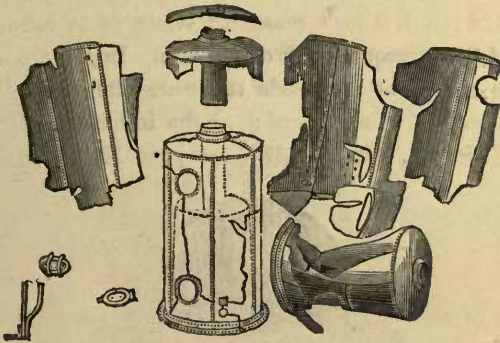
Fig. 28.

Several instances have occurred of explosion of Portable Crane Boilers. Their small size has led to their condition being disregarded, under the idea that scarcely any pressure could burst them. In practice it is found however that they are often exposed to greater pressure than other boilers, because the fire is large and quick in proportion to their size; and they often have to stand for a considerable time with the steam up, and their exposed position and long intervals of rest add to the chances of corrosion, as shown by

the example in Fig. 28, No. 14, 1869. The large manholes without strengthening rings, that are so often put in these boilers, have been the cause of explosions such as that shown in Fig 29, No. 57, 1866,

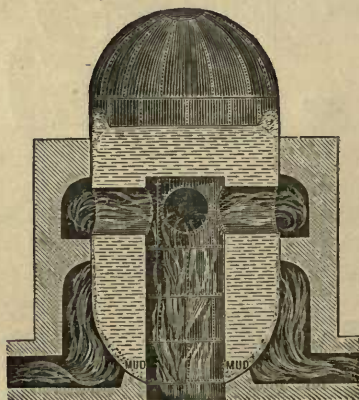
sometimes so rigid as to give no allowance for the expansion of the tube, and the result is such continued strain as to cause constant leaking and the consequent risk of fracture. In furnace boilers the tops of the crowns of the inside tubes are often made flat, as in Fig. 37, instead of being domed; or the inside tube is of undue size, as in Fig. 21, No. 23, 1870, see page 73. Furnace boilers

An attempt is made in Fig. 38 to show the effect of wear and tear of boiler plate in an ordinary upright furnace boiler, such as is shown in Fig. 37. The external surface is exposed to intense heat and consequently expands, while the internal surface is kept cool by contact with the water and expands to a much less degree. The continued repetition of this process produces the same effect of

and an attempt is made to show this action in such an upright boiler as is represented in Fig. 37, page 78, by the enlarged section of the side shown in Fig. 40. The flame is shown impinging on a limited surface, as before, and the steam rises so rapidly from the inner surface as to maintain a continuous stratum of steam between the iron and the water, and the plate consequently becomes overheated at that part. When the intense flame subsides by an alteration of the working of the furnace, the stream of steam diminishes, and the water returns and suddenly cools and contracts the plate, but often not before it has commenced to get out of shape. This has perhaps led to the explosion shown in Fig. 59, No. 37, 1868, page 82. The same thing may happen to the crowns of tubes of internally fired boilers when over fired, as in Fig. 41. Success has attended the use of internal linings to boilers, arranged so as to ensure a rapid circulation over the most heated parts, and also to catch all the mud and loose scale.

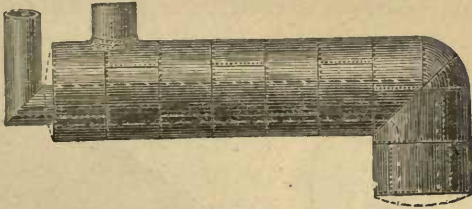
have been made with the omission of the stays that are so peculiarly necessary in that form, whereby both ends have been left free to bulge outwards with the pressure, as in Fig. 32.

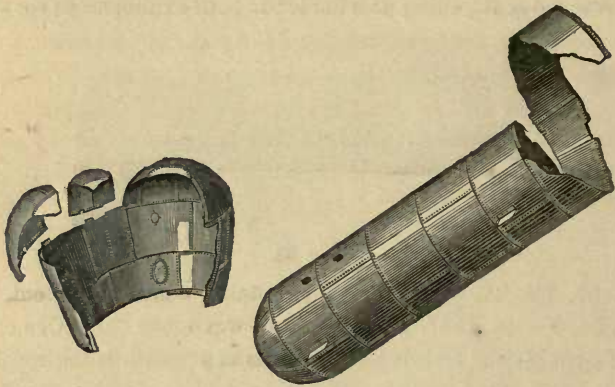
Figs. 15, 16, and 17, see page 70 and 71, No. 10, 1869, and Fig. 36.

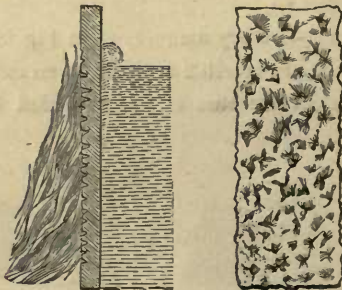
Fig. 38.

cracking the surface as that seen in the anvil blocks of steam hammers; and the strength of the plate is reduced in proportion to the destruction of the continuity of its surface. The deleterious effect of this process is much increased if the boiler is subject to alternate

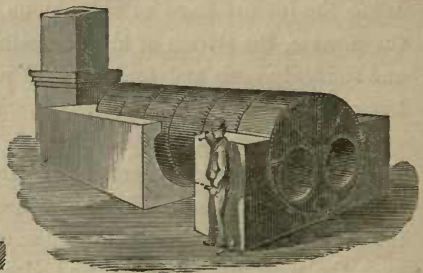
Fig. 44.

the tubes and the end plates and angle iron. It is in the external flues that greater accommodation is needed, as in many cases these are so narrow that the boiler is quite inaccessible without pulling down the brickwork, as in Figs. 44 and 45. The loss of heating effect

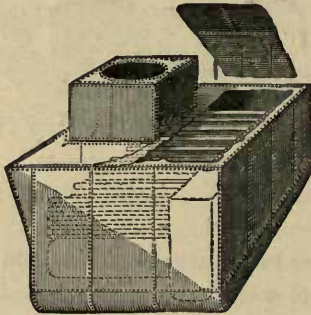
Fig. 57.

Corrosion has been the direct cause of many of the explosions. In one or two cases the corrosion was known to exist, but the renewal of the boiler was too long delayed, as in Fig. 57, No. 8, 1869,

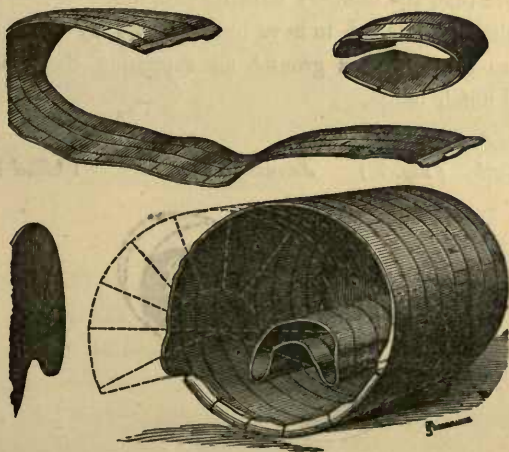
Fig. 1.

No. 2. *Walsall.* (*Fig. 1.*) *January 2nd.* *2 injured.*

Butterley, 26ft. 6in. long, and 9ft. diameter. The waggon-shaped

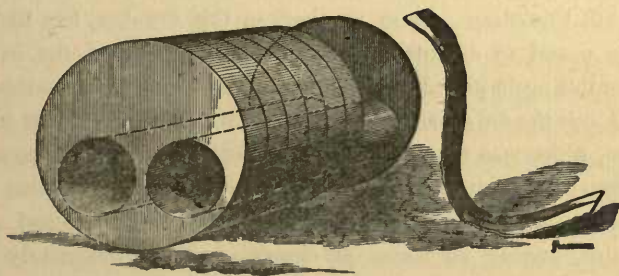
Fig. 3.

No. 5. Glasgow. (Fig. 3.) January 13th. 4 killed, 4 injured.

Two tube Cornish, 22ft. 3in. long, and 7ft. 7in. diameter, $\frac{3}{8}$ inch plates, tubes 2ft. 7in. diameter, 40 lbs.

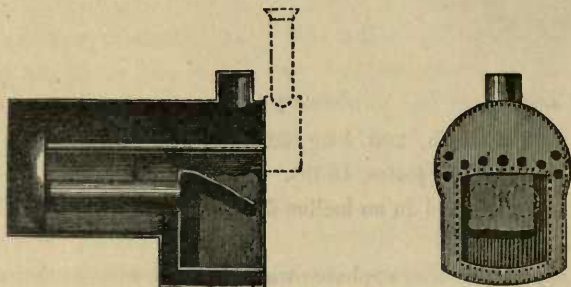
Fig. 4.

No. 7. *York. (Fig. 4.)* *January 18th.* *1 killed, 2 injured.*

Agricultural, 8ft. 2in. long, 3ft. 6in. diameter in the barrel, 5-16ths inch plates, internal fire box, 2ft. 4in. wide, 2ft. 4in. high, and 2ft. 10in. deep. From the back of this fire box, two 12-inch tubes passed to an internal chamber at the back of the barrel. From this again passed nine $3\frac{3}{4}$ inch tubes to an exterior smoke-box fixed over the fire door. The boiler was fitted with one spring safety valve, which was screwed down tight, but there was no pressure guage. The front plate was intended to be bolted on so that the fire-box and tubes could be taken out for cleaning, but it had been rivetted, leaving no means of cleaning, and it was nearly full of scurf.

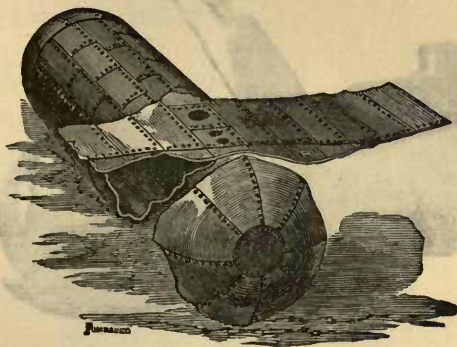
Fig. 5.

No. 8. *Durham.* (Fig. 5.) *January 29th.* 1 killed, 3 injured.

Plain Cylinder Boiler with hemispherical ends, 30ft. long and 6ft. diameter, $\frac{3}{8}$ inch plates, 30 lbs. It was the second from the engine in a bed of five, and had been at work three years, then remained idle for eight years, working again fourteen years. The boiler was mounted with two safety valves $3\frac{7}{8}$ and 4 inches diameter, a float and alarm whistle. The boiler had been more than once repaired over the fire with several new plates. One seam over the fire had been observed to leak about a week before the explosion, but not seriously, and had been caulked. The boiler had just been started after cleaning. Six months before explosion, the boiler had been tested to 69 lbs.

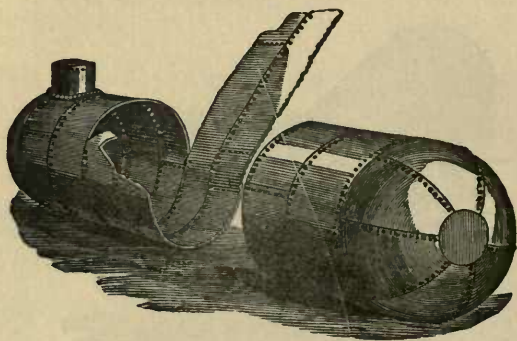
Fig. 5.

No. 9. Birmingham. (Fig. 5.) February 7th. 1 killed, 4 injured.

Plain Cylindrical Boiler, with hemispherical ends, 23ft. long, and 5ft. diameter, $\frac{3}{8}$ inch plates, 50 lbs. It was set so as to be fired under the bottom if required, but the grate was seldom used. The principal heat was supplied from a mill furnace, the neck of which was at the left hand of the back, and the flame was carried by a wheel flue round the front of the boiler to the stack on the right hand side of the back. The boiler was fitted with a $4\frac{3}{4}$ -inch safety valve, and also a float, but it was suspected that the latter had broken from the rod.

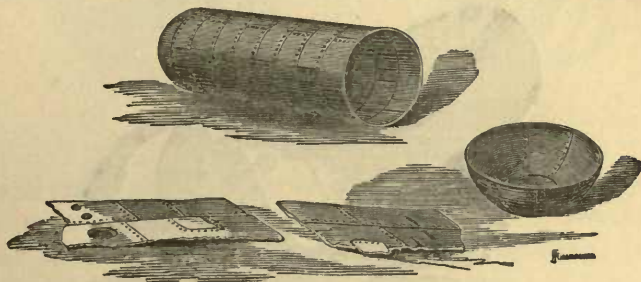
Fig. 10.

No. 17. *Dudley.* (Fig. 10.) *March 19th.*

Plain Cylinder Boiler, 36ft. long, 5ft. 6in. diameter, 60 lbs. It had frequently been repaired over the fire, so that the longitudinal seams ran for several plates without break of joint. A patch had been put on a few days before explosion, and as the rivet holes had badly fitted, there had been much strain caused by drifting, and the rivets were much distorted.

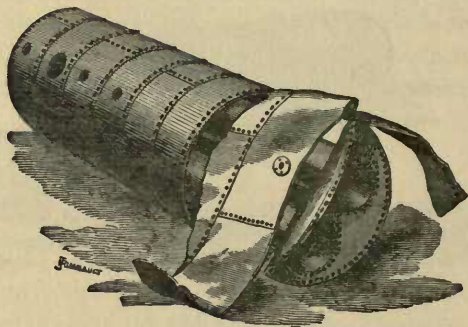
Fig. 11.

No. 19. *Leeds.* (Fig. 11.) *March 27th.* *2 killed, 18 injured.*

Two Tube Cornish, 24ft. 6in. long, 6ft. 6in. diameter, tubes 2ft. 6in. diameter, $\frac{3}{8}$ inch plates, 54 lbs., fitted with steam gauge, blow-off cock, 1 $\frac{1}{2}$ inch dead weight safety valve, loaded to 54 lbs., and 4 $\frac{3}{8}$ inch lever safety valve, loaded to 62 lbs., and had been at work about five years.

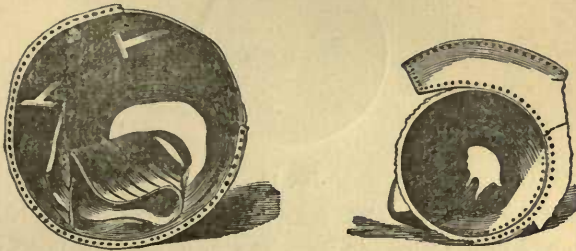
Fig. 12.

The tube collapsed from end to end. The front end was blown out with a short length of the tube attached, and was driven against

a wall about 30 yards to the front. The main body of the shell, and the back end, with the collapsed tube within it, were driven back against another wall, about the same distance away. Very great damage was done to the surrounding property.

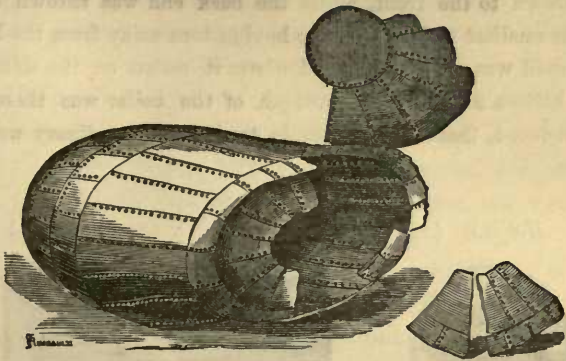
Fig. 14.

as a little more steam than usual had accumulated, the bottom gave

way, and the reaction of the issuing contents made the boiler rise from its seat, and it fell on its side at some distance away flattened by the fall.

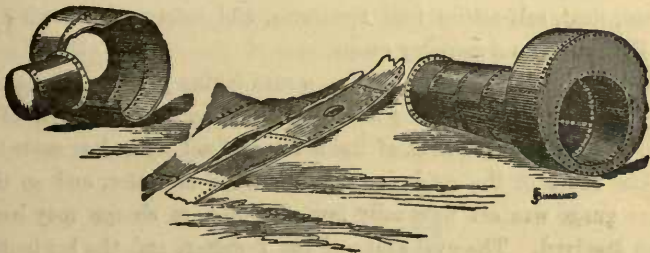
Fig. 15.

No. 25. *Westbromwich.* (*Fig. 15.*) *May 25th.* *none injured.*

One Tube Cornish Boiler, 15ft. long, and 4ft. 6in. diameter, taper tube, 2ft. 9in. diameter in front, and 2ft. diameter at back, $\frac{3}{8}$ inch plates, 40 lbs. The boiler rested on two walls forming the bottom flue. There was a safety valve, a glass water gauge, a pressure gauge, and two fusible plugs upon the tube.

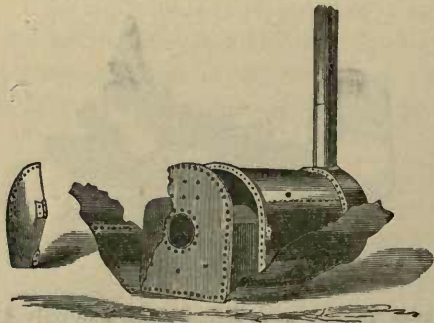
Fig. 18.

No. 32. *Barnard Castle.* (*Fig. 18.*) *June 11th.* *2 injured.*

Agricultural, of about 7 horse power. The barrel of the boiler

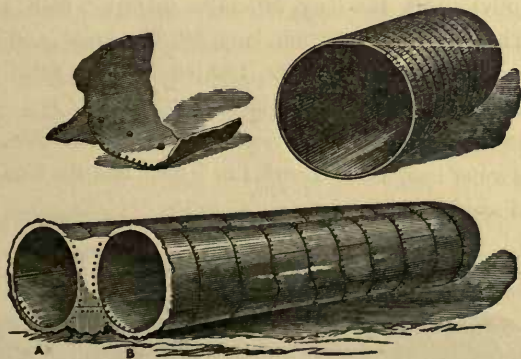
Fig. 19.

No. 42. *Tunstall. (Fig. 19.) July 28th.*

Boiler, 36ft. 6in. long, and 8ft. 9in. diameter, $\frac{7}{16}$ inch plates, with flat back and hemispherical front end, 36 lbs. A tube 3ft. 3in. diameter, passed from the back end nearly to the front, and returned

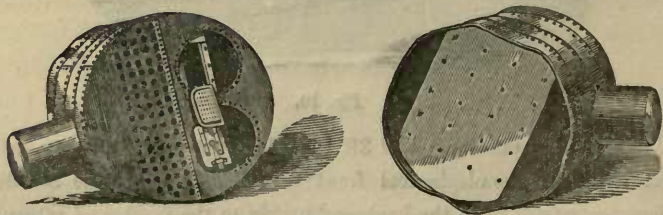
Fig. 20.

No. 45. *Runcorn.* (Fig. 20.) August 22nd. 3 killed, 5 injured.
